Manhole Inspection Summary

Manhole # S29Q1_013MH

Insp Date: **2/22/08 10:34 AM**

Location Address: **2860 Bookert Dr**

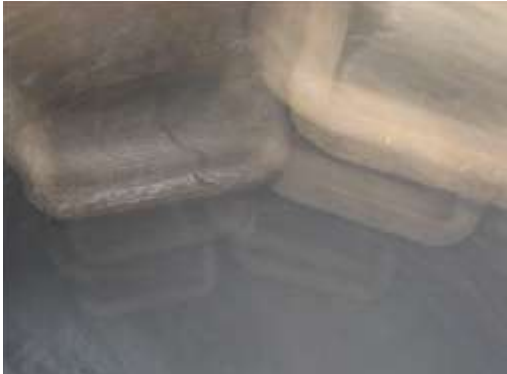
steps

Count: **6** Missing: **0** ☒ **Corroded**

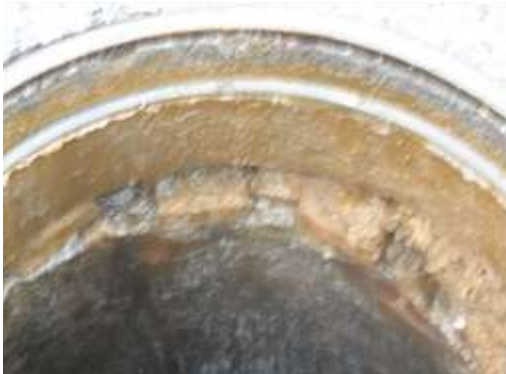
Defect 1

Condition: ☐ Sound ☐ Cracked ☐ Root Intrusion ☒ **Loose Brick** ☐ Deteriorated

loose chimney bricks

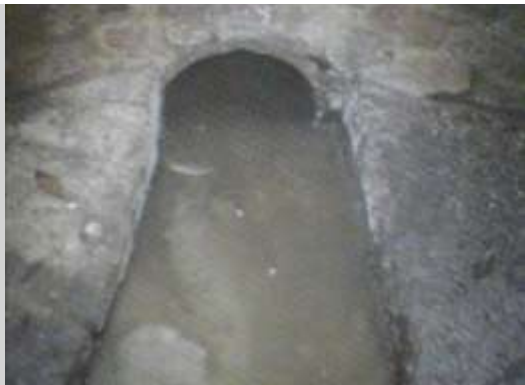
5 O'Clock Inflow

Pipe Height: **9.6** (in.) Rod and Bar (Angled)
Pipe Material: **Clay** ☐ Pipe Lined
Invert Depth: **11.86** (ft.) Flow Characteristics: **Slow**
Deposits: ☒ None ☐ Mud ☐ Sludge ☐ Debris ☐ Grease
Silt Depth: (in.) Deposits Extent:
Infiltration: **None** Pipe Seal Cond: **Sound**

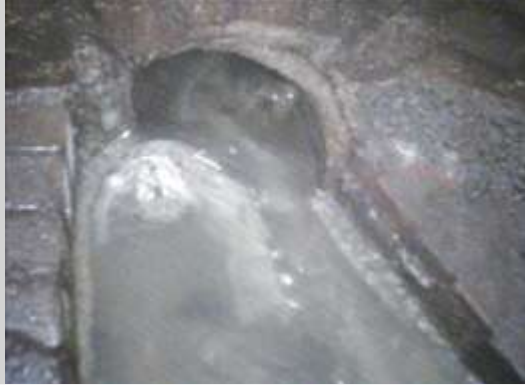
7 O'Clock Inflow

Pipe Height: **8.4** (in.) Rod and Bar (Angled)

Infiltration: **None** Pipe Seal Cond: **Sound**
